EVALUATION OF THE FUZING SYSTEM FOR THE
MISSILE "LOON" (JB-2)

12 August 1952

U. S. NAVAL ORDNANCE LABORATORY
WHITE OAK, MARYLAND

~~CONFIDENTIAL~~
NAVORD Report 1876

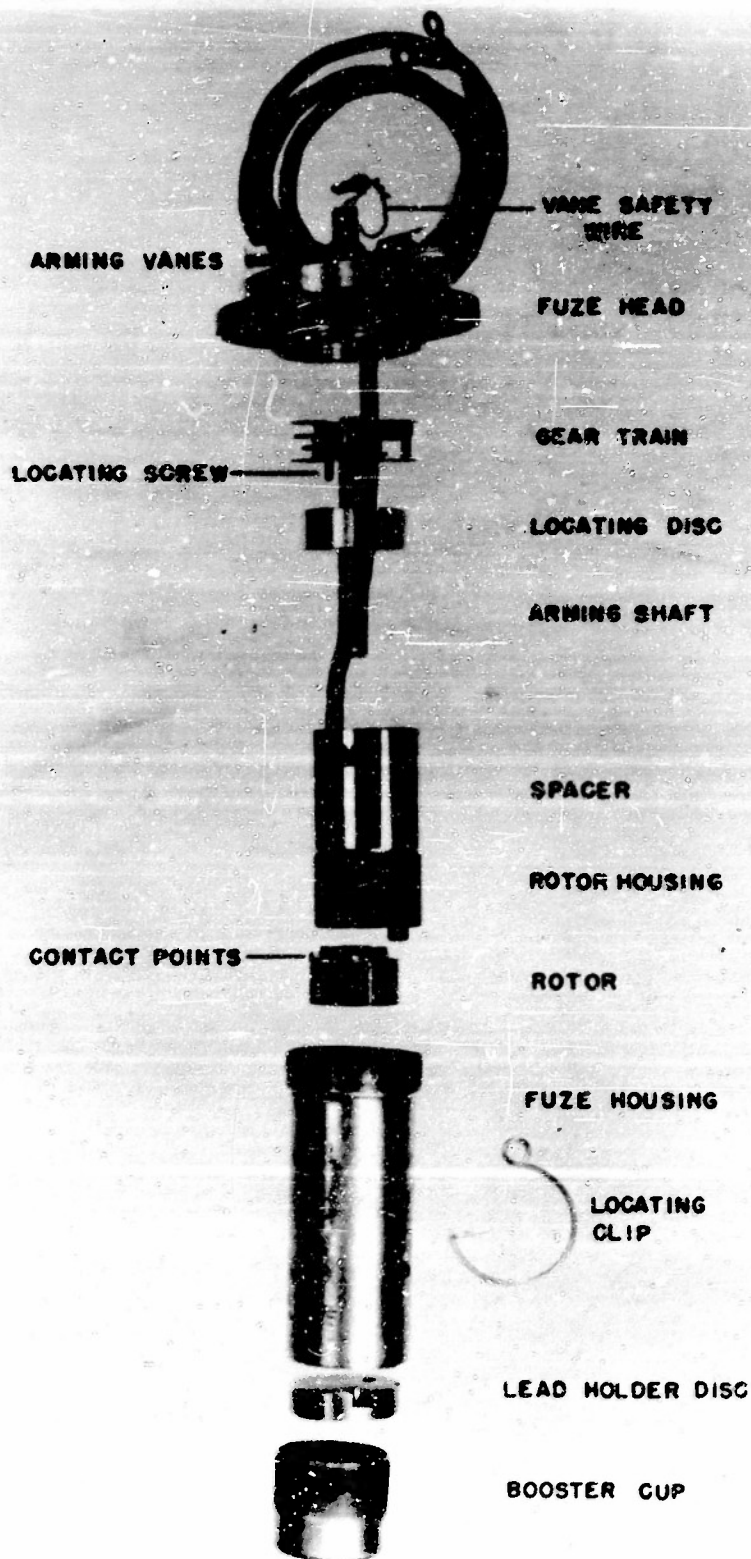
FIG. 4 T74E3 FUZE (EXPLODED VIEW)

- a. One booster cup came unsealed.
- b. One fuze sleeve came unsealed from the fuze head.
(The booster cup and fuze sleeve are sealed by using Petman cement).
- c. The small locating screw (figure 4) which holds the gear housing to the locating disc inside the spacer was loosened

in three of the fuzes. All detonator bridge wires were continuous after the test. In general the ten samples showed no unreasonable wear or no serious damage, and therefore were safe and operable.

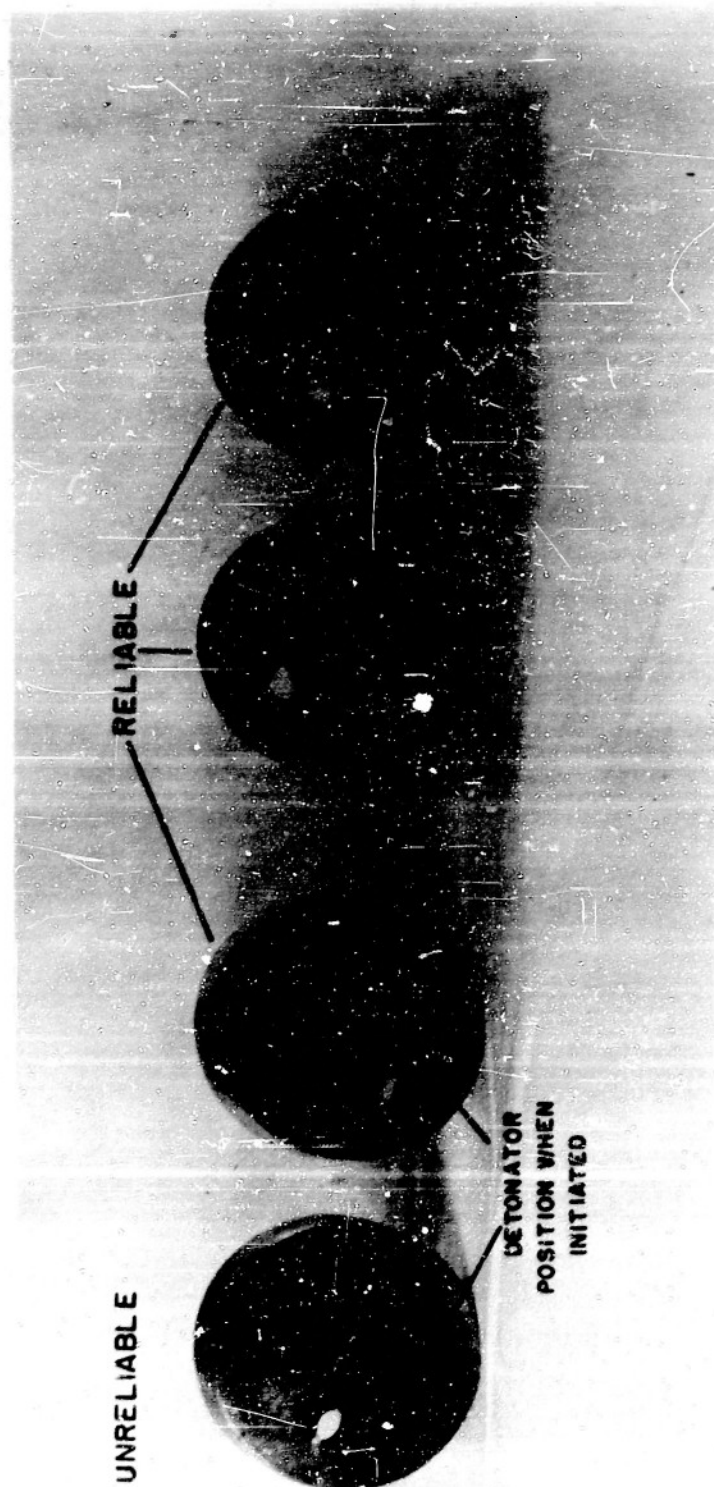
FIG. 5

23. Seven fuzes were allocated to the Military Standard Jolt Test for Use in Development of Fuzes (MIL-STD-300). Initially four samples were tested. The boosters in these samples failed to maintain their pellet form, but crumbled to a fine powdery dust; consequently this tetryl dust spread in varying amounts throughout the fuze. Considerable tetryl was found even in the gear train housing. Approximately half the tetryl came out of the booster cup. As a result of this, new pellets were made and installed in all the remaining fuzes. The new booster was

made up of two small pellets in place of the larger one. Three more units with new boosters were given the Military Standard Jolt Test. These boosters were in good condition at the end of the test and there was no tetryl dust inside the fuzes. Of the original four fuzes jolted, three booster cups came unsealed. None of the last three fuzes which were resealed with glyptal came unsealed. Due to the vertical motion of the detonator in the rotor, lead wires broke off at the base of the detonator in five out of the seven fuzes. The detonators were displaced about 1/16th inch from their normal positions, thus increasing the spacing between the detonator and lead disc (figure 5). In five of seven fuzes the vane safety wires came off. The locating clip did not come out in any of the fuzes. The rotor was in good condition; however, the bakelite rotor housing was broken in two of the fuzes. In two of the fuzes the aluminum locating disc (figure 4) on which the gear train is mounted, came loose and fell down inside the cylindrical spacer. In four of the fuzes this disc was being held by a few threads of the locating screw. In one unit the three Philips-head screws that hold the rotor housing to the cylindrical spacer came out. Firing leads connecting the spring contacts in the rotor housing were also broken off in this fuze. Of the seven fuzes jolted, one fuze would have been operable. The remaining six would not have been operable either due to broken connecting leads or the broken rotor housing. Bridge wires on the undamaged detonators were continuous.

(b) BOOSTER

(a) ROTOR FROM JOLT TEST

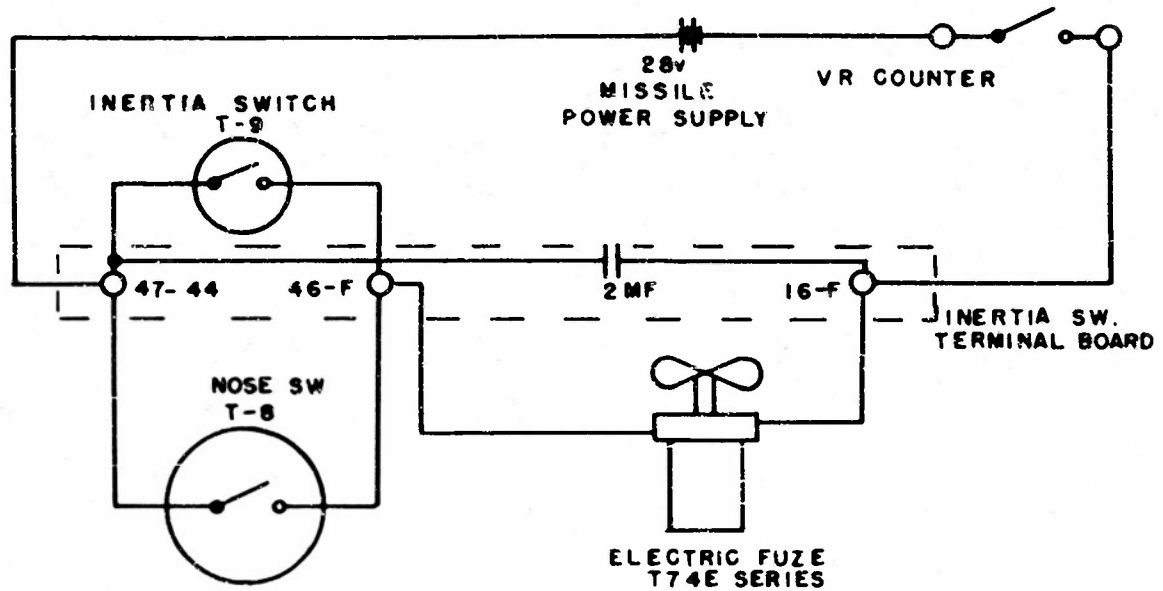
DIAGRAM OF ORIGINAL FIRING CIRCUIT

6. Figure 8 shows the original circuit for the electrical components of the fuzing system. As can be seen from the diagram, at least three switches must close before the electrical fuze will fire. Two of these, the Veeder-Root counter and the fuze arming switch, are safety features and are closed by air travel. After these close, the weapon is fully armed and the warhead will be exploded upon closure by impact of the nose switch and/or the inertia switch.

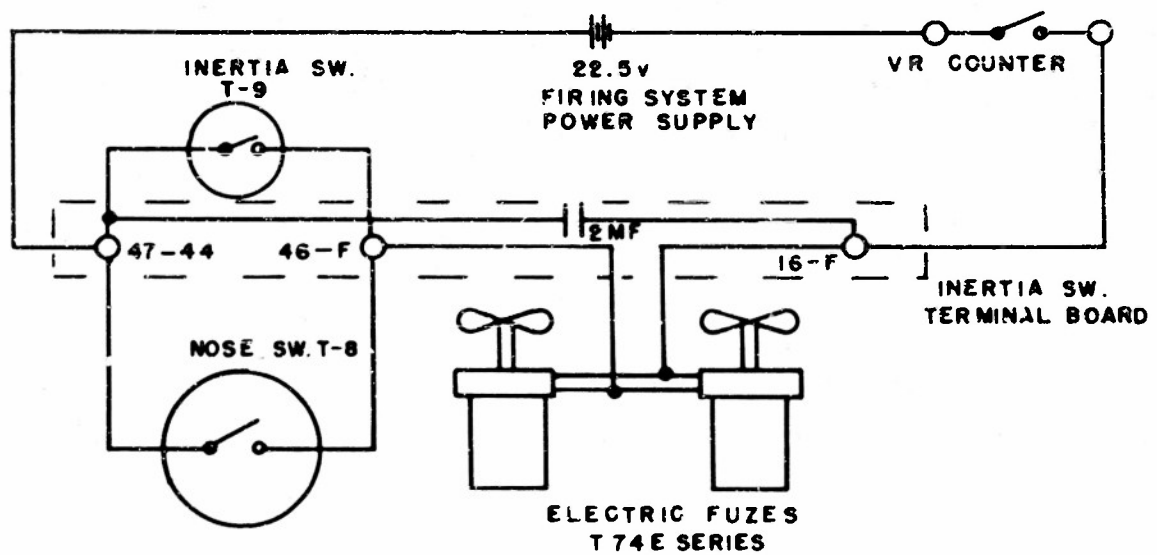
FIG. 8
DIAGRAM OF MODIFIED FIRING CIRCUIT

7. Figure 8 shows the modified circuit for the electrical components. The modifications are discussed in paragraphs 9 and 13 following.

9. The mechanical fuze T84E series was declared unsafe for Naval use, and will be discussed in paragraph 20. As a substitute for this component, it was decided to use an additional electrical fuze of the T74E series. The T74E series and the T84E series have the same external dimensions, which allowed the substitution to be readily made. The two electrical fuzes were connected in parallel as shown in figure 8.

c. The present system of controlling the end trajectory of the missile provides for diving the entire fuselage into the target by blowing off the wings, stopping the pulse jet engine and removing the forces which control the tail surfaces so they will assume a neutral position. The trajectory of the fuselage then approximates that of a free falling bomb. One wing is blown off a fraction of a second after the other to give the fuselage an initial spin to improve the consistency of the trajectory. Previous tests by the NAMTC have shown that wing blow-off and/or the displacement of components due to spin usually result in the missile power supply battery being shorted. To prevent the live-loaded missile from becoming a dud from this cause, a separate 22.5 volt dry battery was provided as a power supply for the fuzing system. It was mounted in a special bracket on the under side of the inertia switch mounting bracket and was connected as shown in figure 8.

b. If the present method of controlling the terminal trajectory (wing blow off) is used, it is recommended that the system described in the published information (reference (b)) be changed to the system shown in figure 8. This change consists of:

(1) Replacement of the T84E series mechanical fuze with a T74E series electrical fuze connected in parallel with the original T74E series electrical fuze (the T84E series is not recommended in any case).

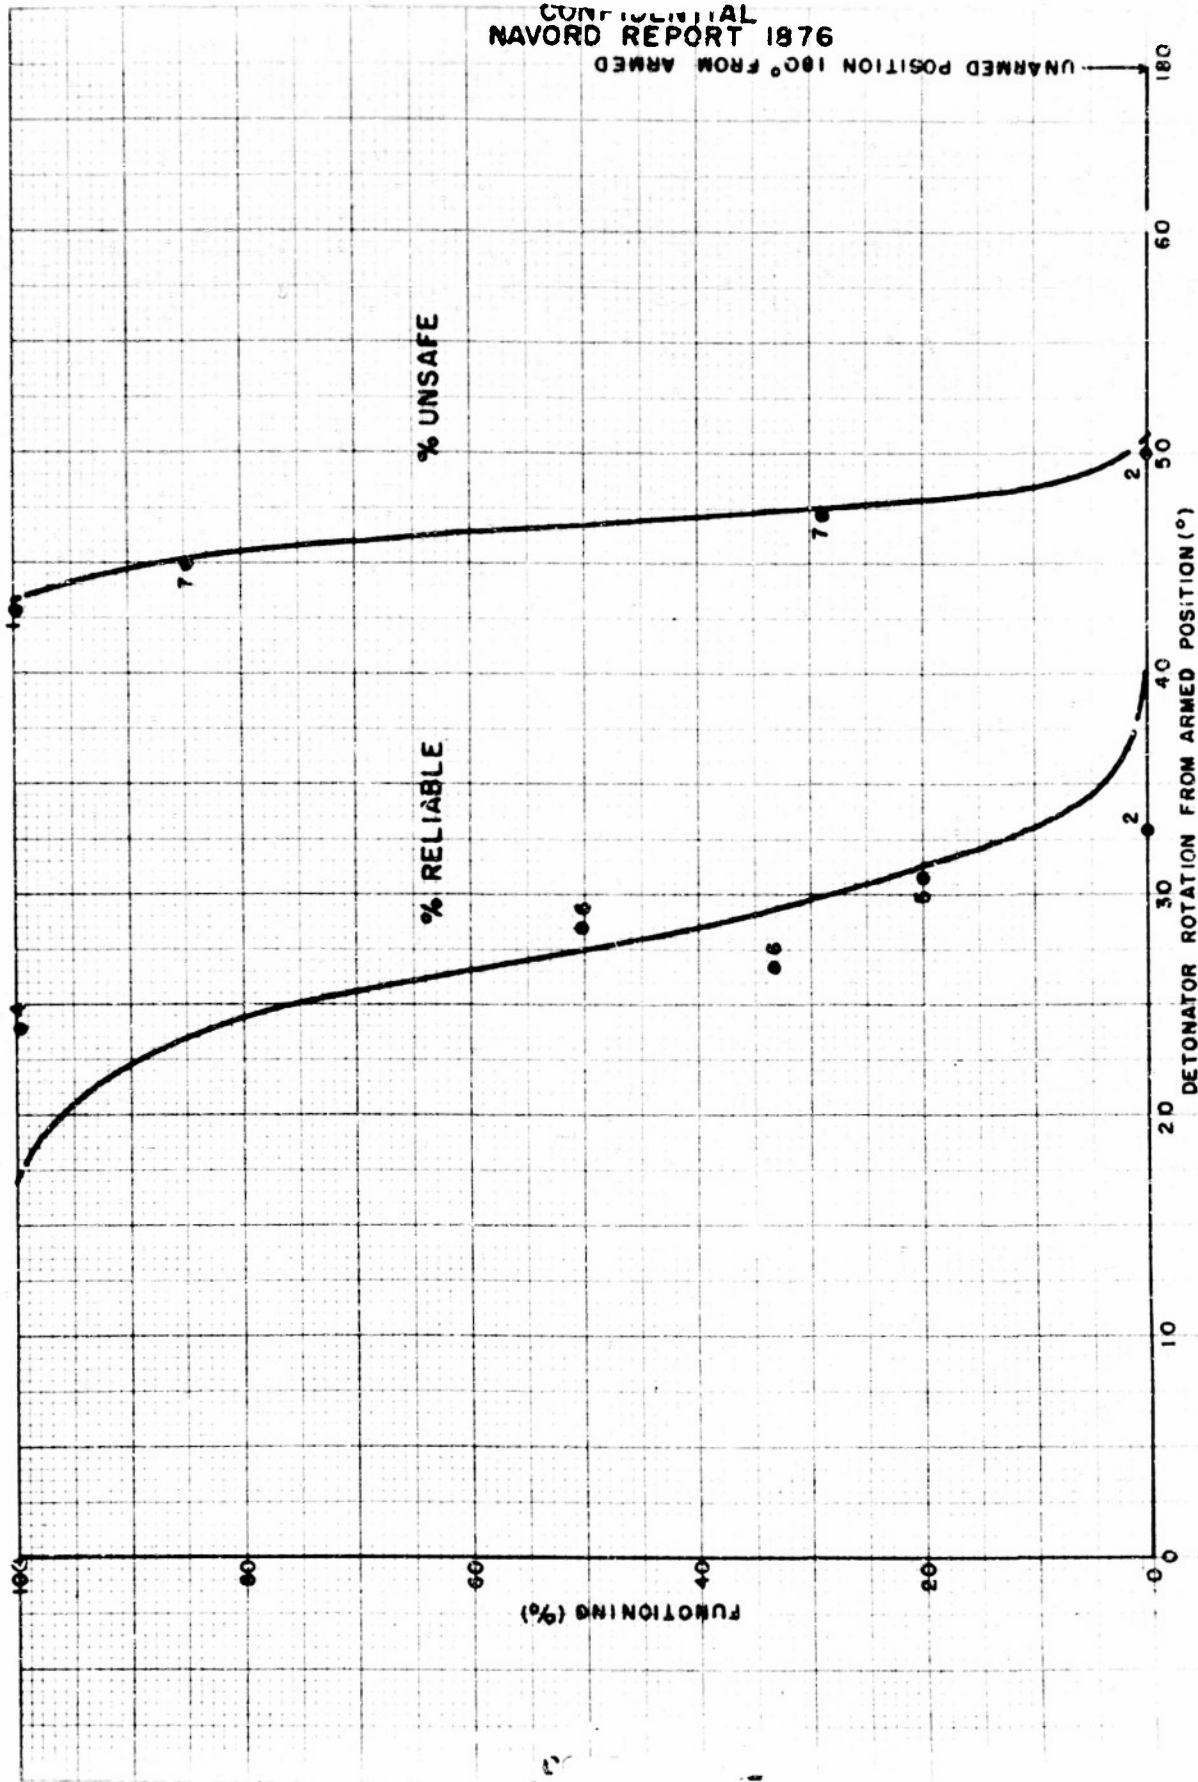
FIG.12 DETONATOR SAFETY AND RELIABILITY

however, these calculations are the best estimate that may be obtained from the data. Referring to figure 12, it is seen that the 50% points of the reliability and the unsafety curves are about 20° apart. In view of this condition, the judgment of the unsafe position does not appear to be too severe, even though there was no visible rupture of the lead cup or burning of the tetryl.

g. The 0.1% unsafe position was predicted to be 51° from armed. Since the completely unarmed position is 180° from armed, the fuze appears safe in this respect.
